INDOOR AIR QUALITY ASSESSMENT

**Manchester Memorial Elementary School
43 Lincoln Street
Manchester, Massachusetts**

Prepared by:
Massachusetts Department of Public Health
Center for Environmental Health
Bureau of Environmental Health Assessment
Emergency Response/Indoor Air Quality Program
September 2004

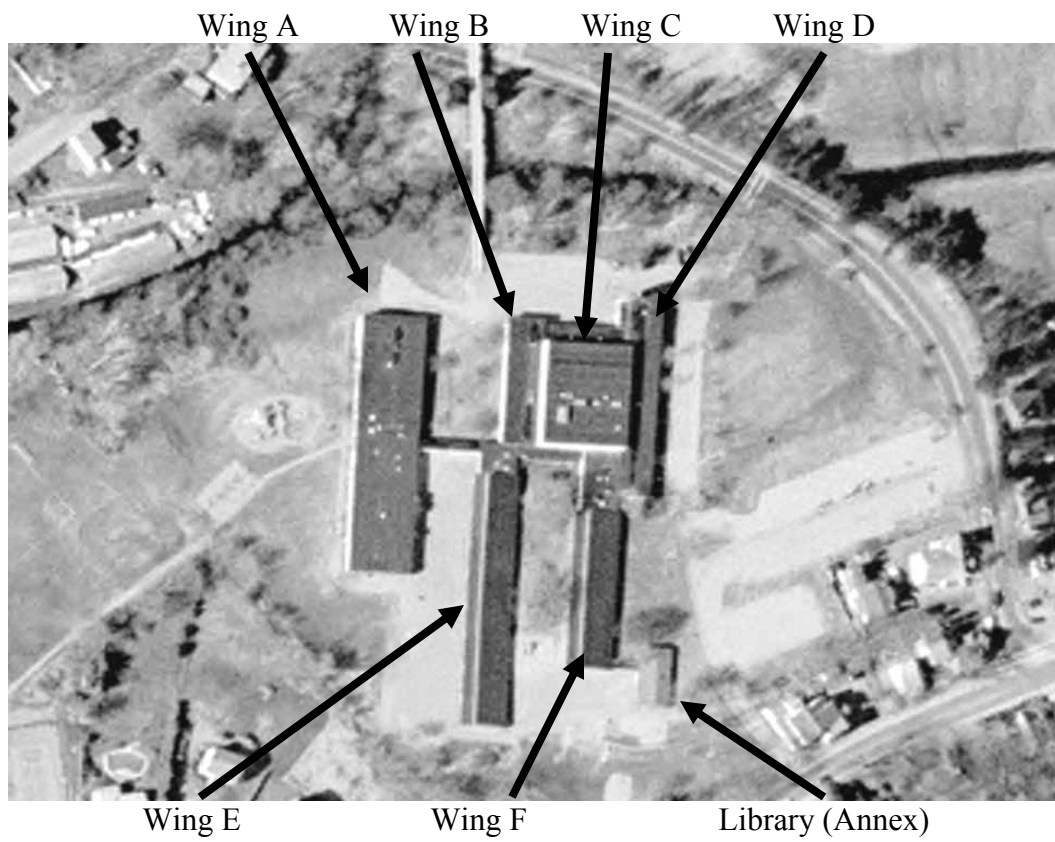
Picture 1

Manchester Memorial Elementary School (MMES)

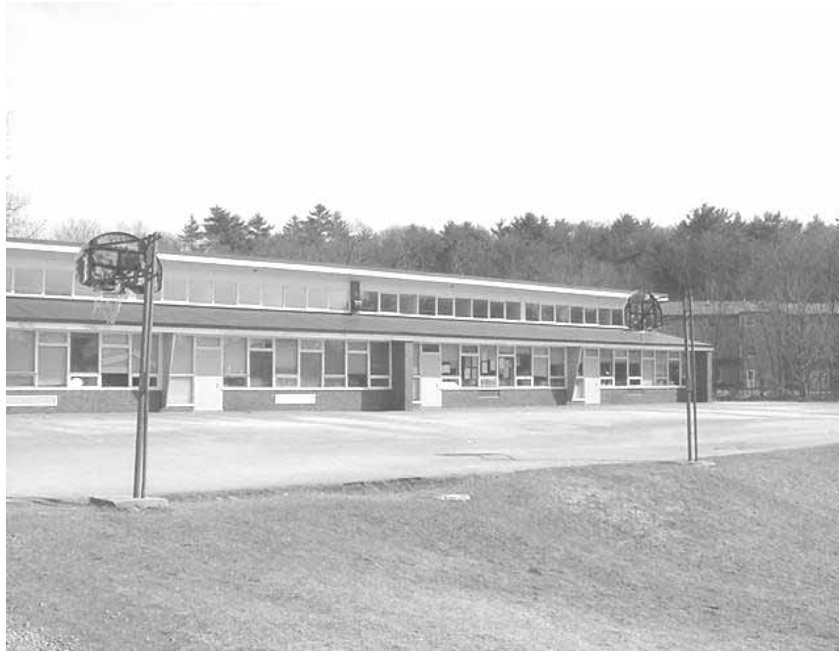
Picture 2

A number of rooms had water-stained ceiling tiles that were evidence of historic leaks through the skylight system. Water-damaged ceiling tiles can provide a source of

One-Story Wings With a Roof/Skylight System

mold growth. Water-damaged ceiling tiles should be replaced after a water leak is discovered and repaired. The school has a ceiling tile system where tiles are glued directly to the ceiling/walls (Picture 6). Replacement of these ceiling tiles is difficult, since their removal appears to necessitate the destruction of the tile. Appropriate measures should be taken to minimize the aerosolization of particulates from tile removal/replacement.
